Asbestos NESHAP & Lead Survey

Performed at:
Lake City VA Medical Center
619 South Marion Avenue
Lake City, FL 32025

OHC Project #160028-AL

**Re: Asbestos NESHAP & Lead Survey
Lake City VA Medical Center
Mechanical & Plumbing Improvements Project
Buildings 19, 38 & 64
OHC Project No. 160028-AL**

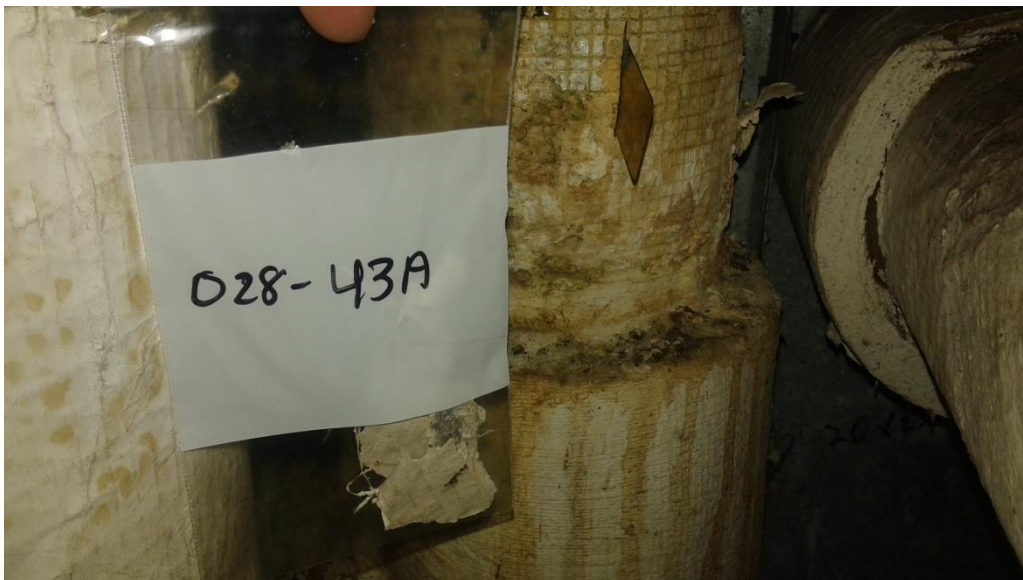
HSA-43

White mastic associated with black stink rock on chilled water pipe
[Building 19 Room 115 – AC-5]

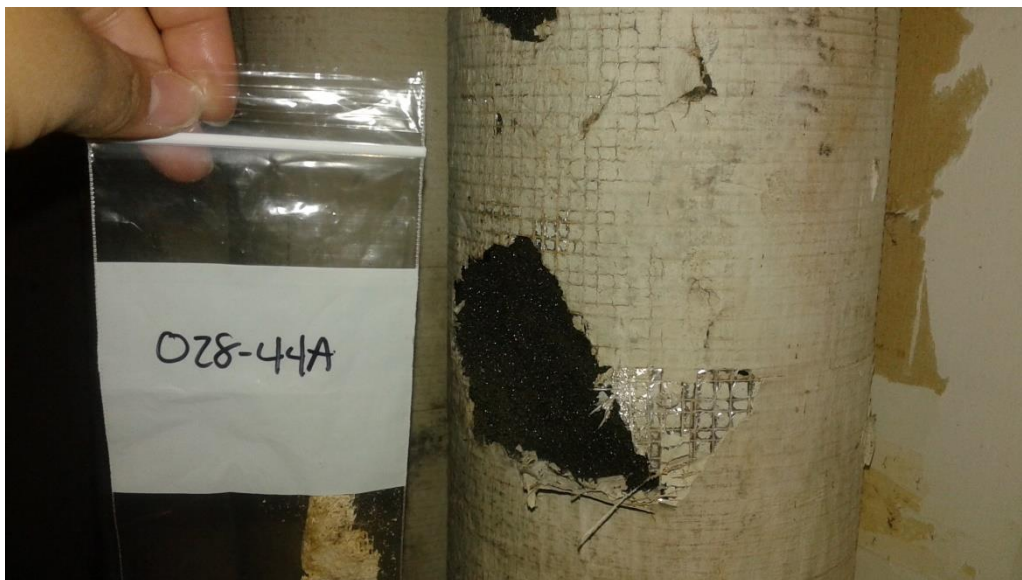
HSA-44

White paper foil wrap associated with black stink rock on chilled water pipe [Building 19 Room 115 – AC-5]

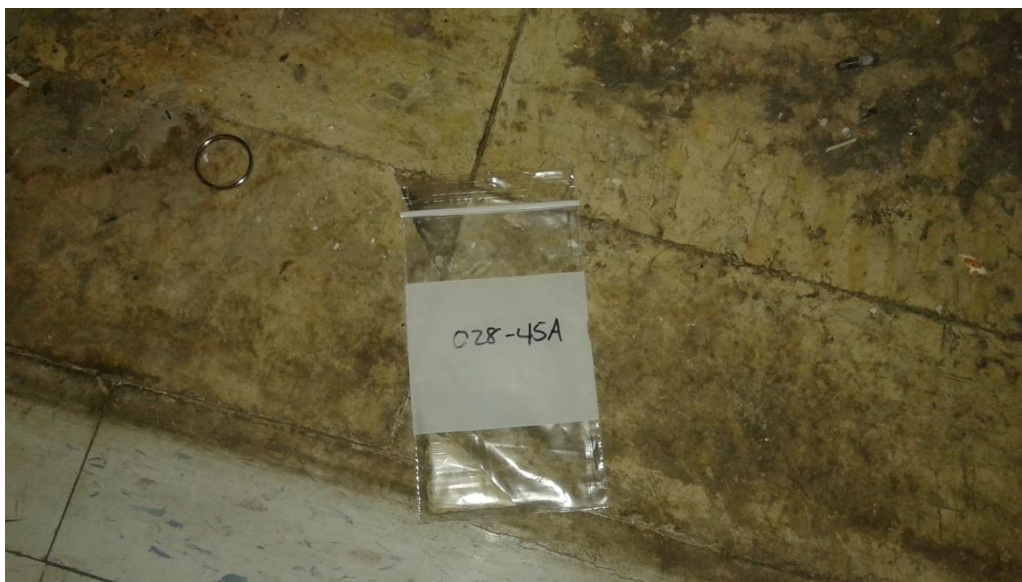
HSA-45

Beige 12x12 vinyl floor tile associated with black mastic [Building 19 Room 115]

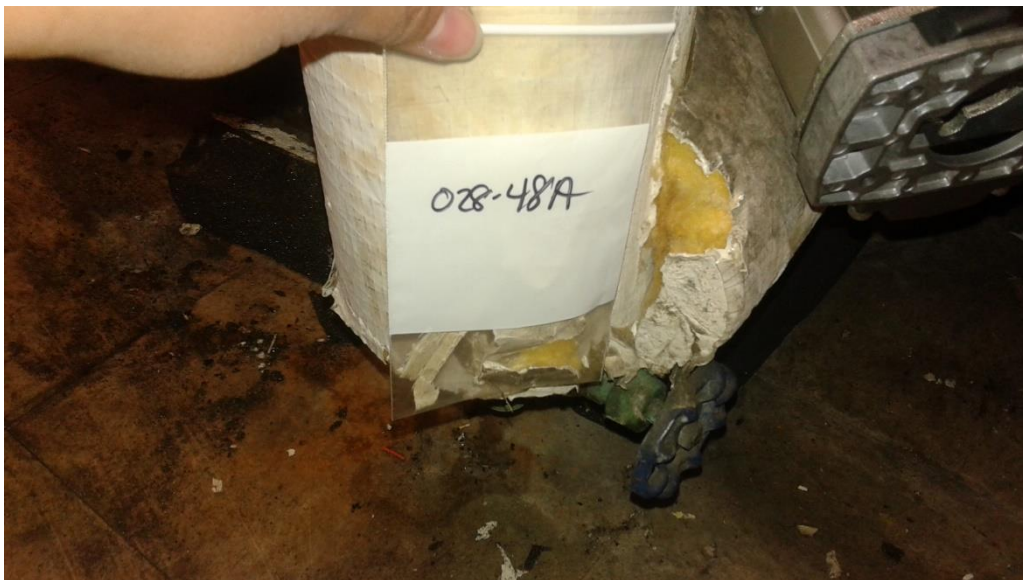
HSA-48

White mastic associated with wrap and yellow insulation on hot water
pipes [Building 19 Room 103 – AC-4]

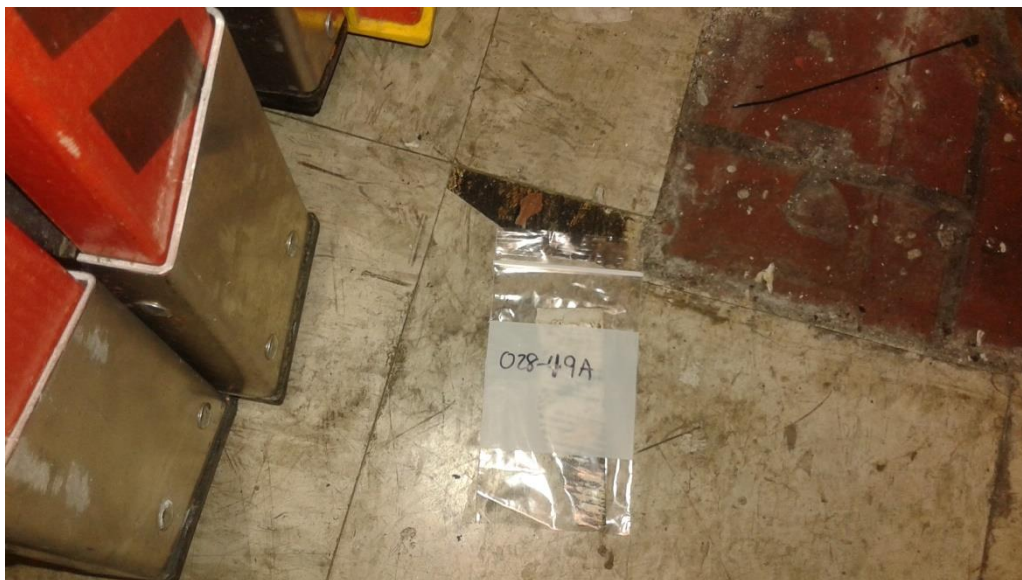
HSA-49

Beige 12x12 vinyl floor tile associated with black mastic
[Building 19 Room 103]

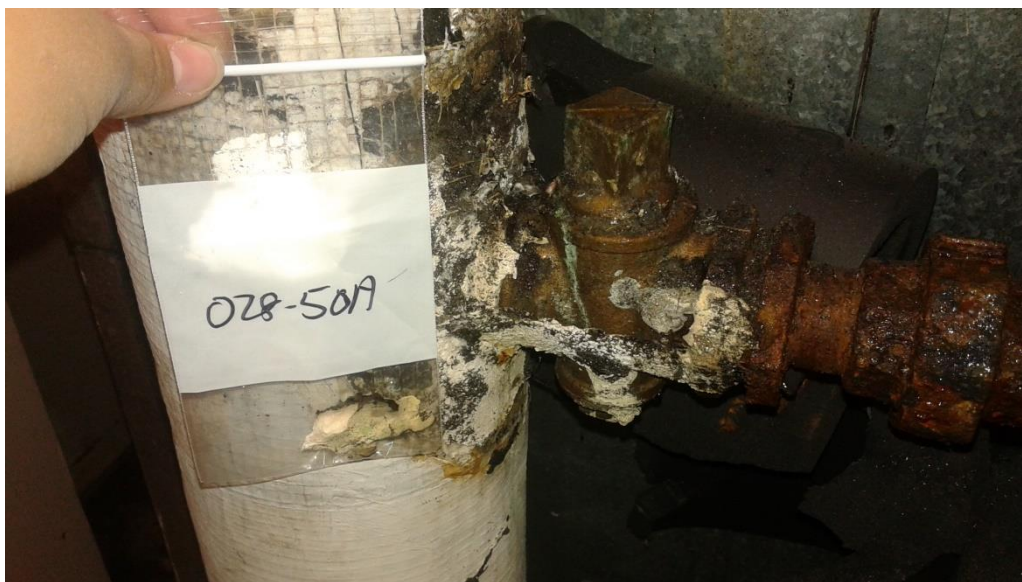
HSA-50

White mastic associated with black stink rock on chilled water pipes
[Building 19 Room 103 – AC-4]

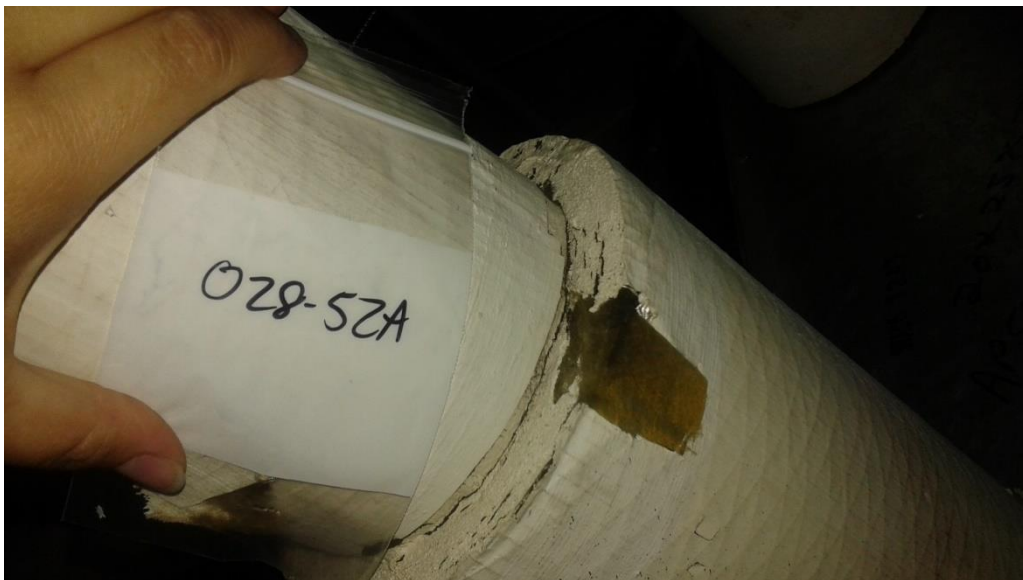
HSA-52

White mastic associated with black fiberglass insulation and wrap on hot water pipe [Building 19 Canteen plenum – AC-2]

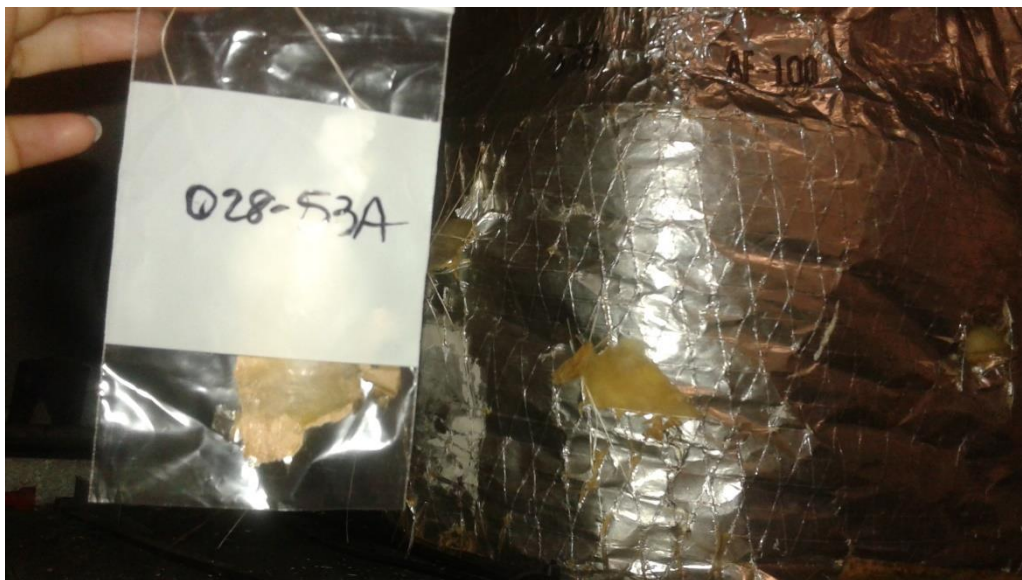
HSA-53

Yellow mastic associated with yellow fiberglass insulation and wrap on ductwork [Building 19 Canteen plenum – AC-2]

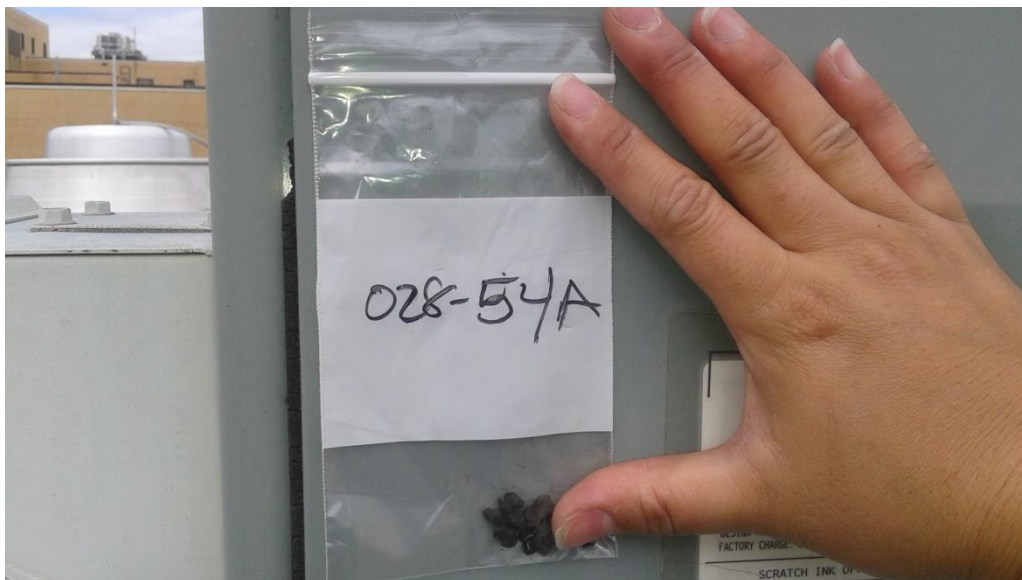
HSA-54

Black gasket between metal panels on AHU
[Building 19 Kitchen Rooftop – RUUD unit]

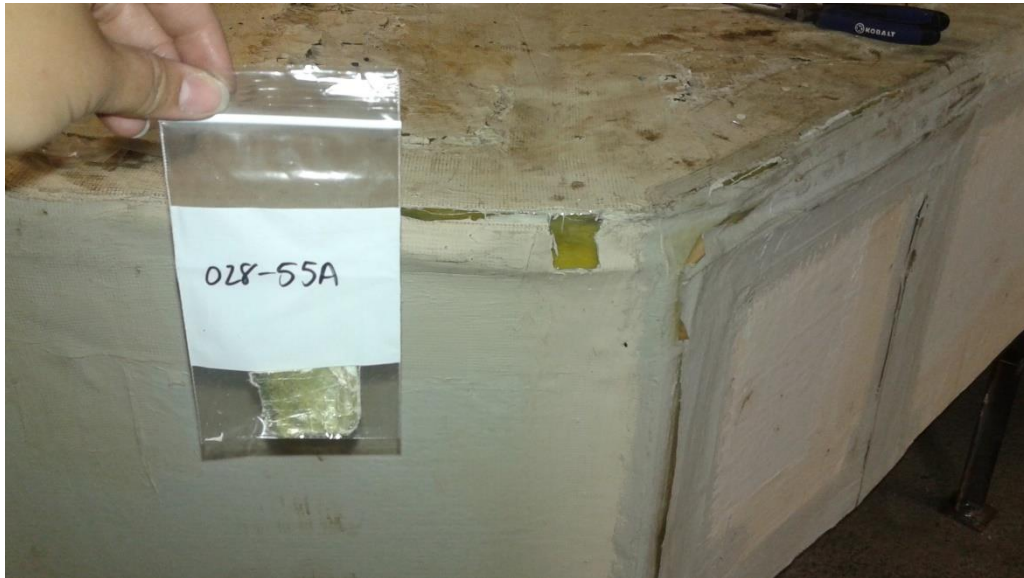
HSA-52

White mastic associated with yellow fiberglass insulation and wrap on ductwork [Building 38 Attic Area – AHU-1 & AHU-2]

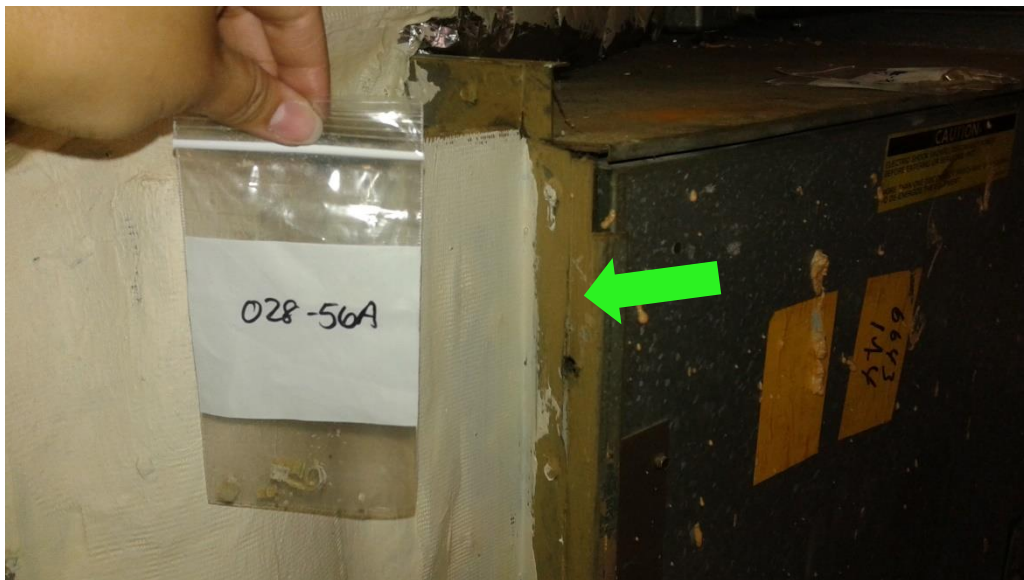
HSA-56

Light brown mastic on exterior of metal AHU panels
[Building 38 Attic Area – AHU-1 & AHU-2]

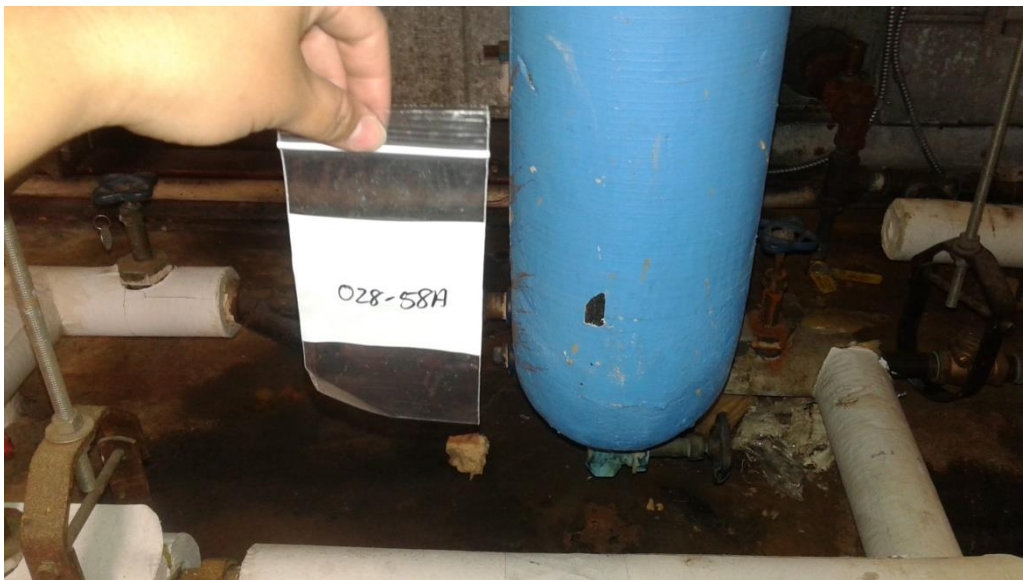
HSA-58

Blue wrap associated with white mastic on chilled water supply line [Building 38 Attic Area – AHU-1 & AHU-2]

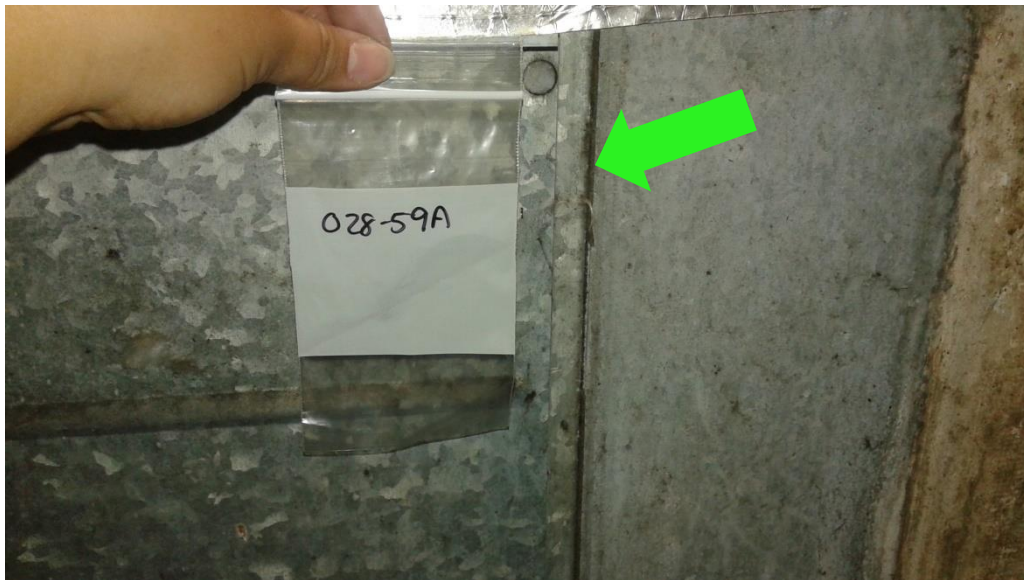
HSA-59

Black gasket between metal AHU panels
[Building 38 Attic Area – AHU-1 & AHU-2]

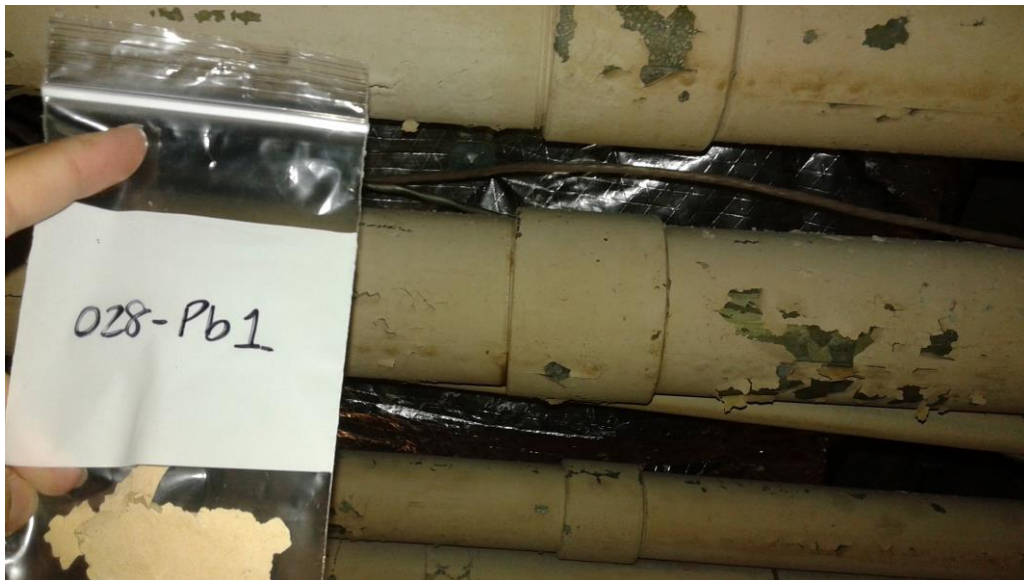
028-Pb1
Beige paint on pipe conduit (LCP)
[Building 64 Room BB26]

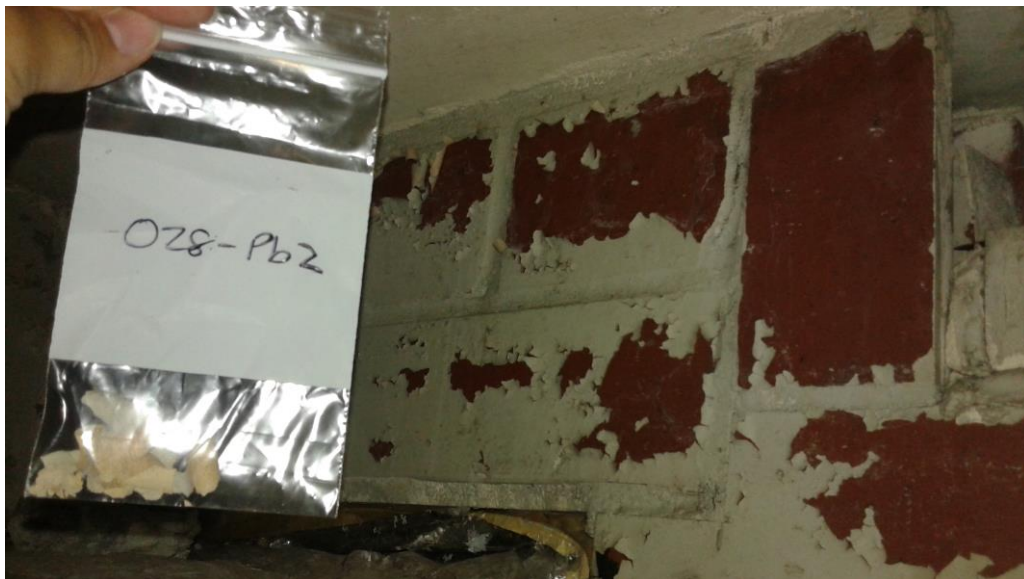
028-Pb2
White paint on cinderblock wall (LCP)
[Building 64 Room BB26]

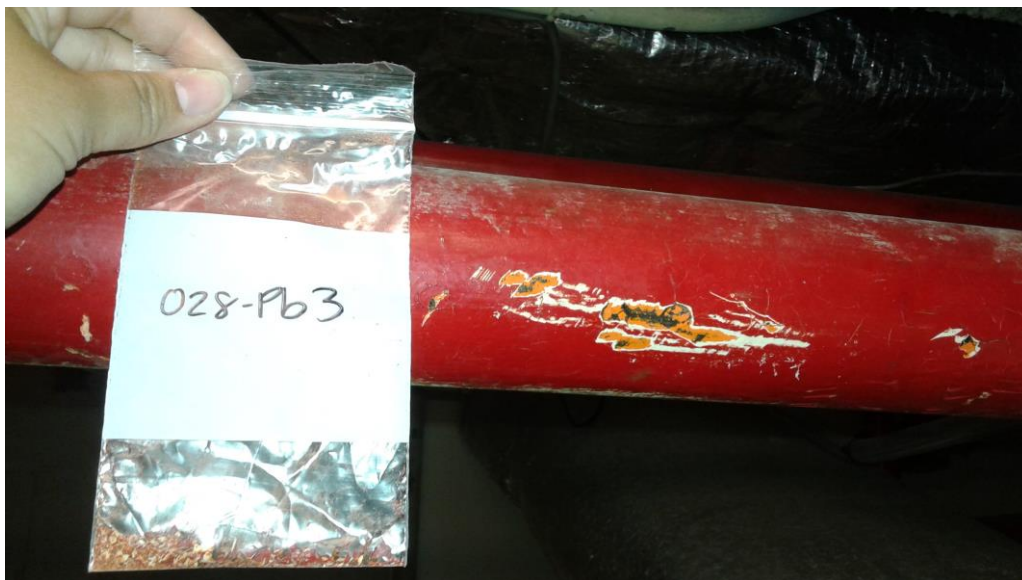
028-Pb3

Red & orange paint on fire sprinklers (LBP)
[Building 64 Room BB26]

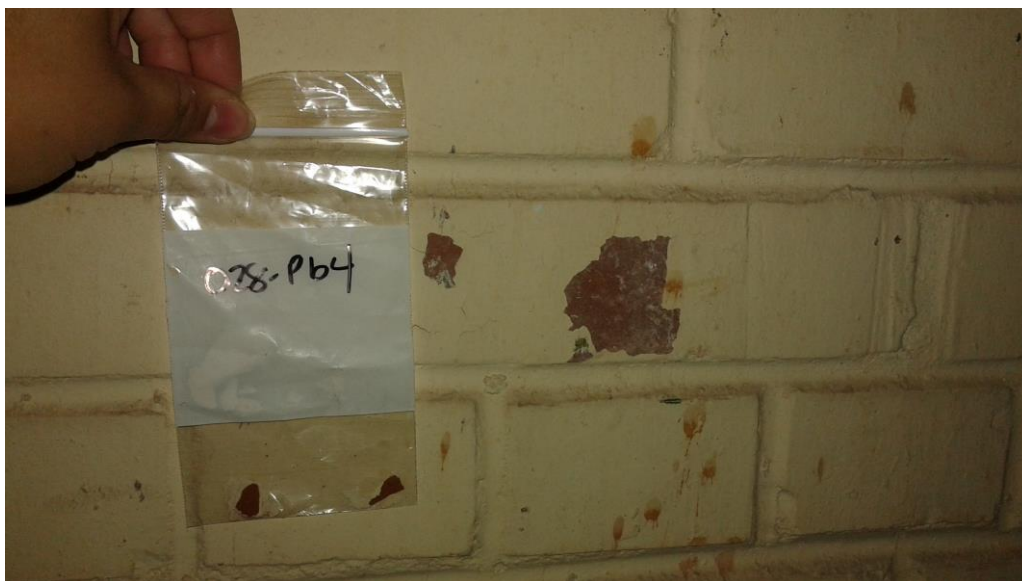
028-Pb4

Beige paint on brick wall (LCP)
[Building 64 Room AB05]

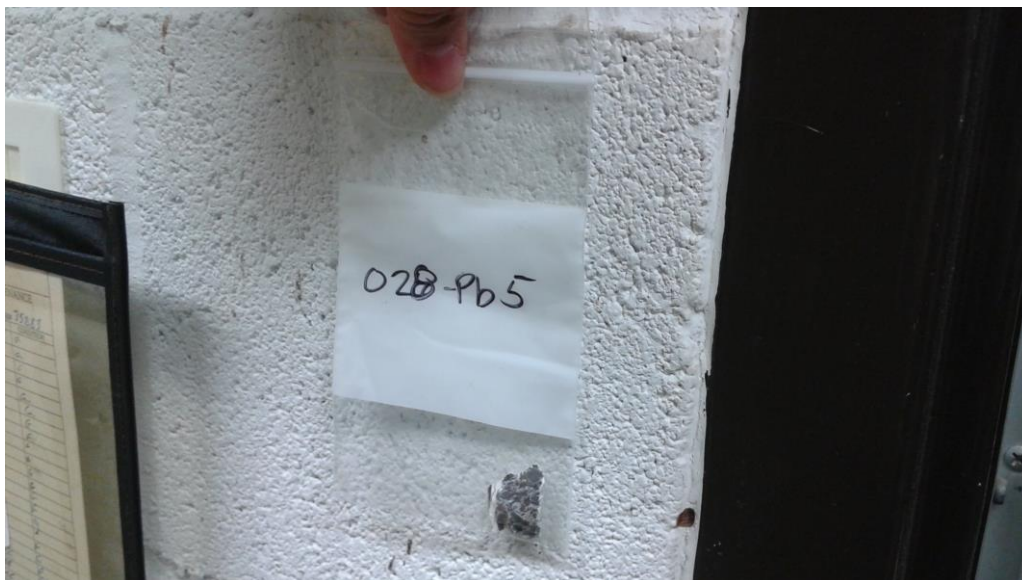
028-Pb5

White paint on brick wall
[Building 64 Room AB30]

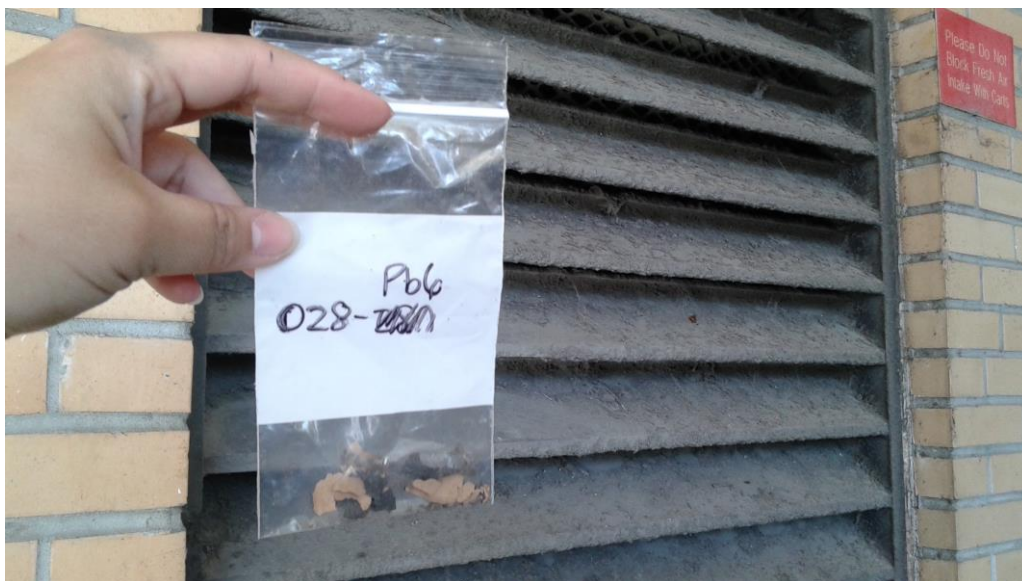
028-Pb6

Black paint on exterior louvres
[Building 64 Room AB30]

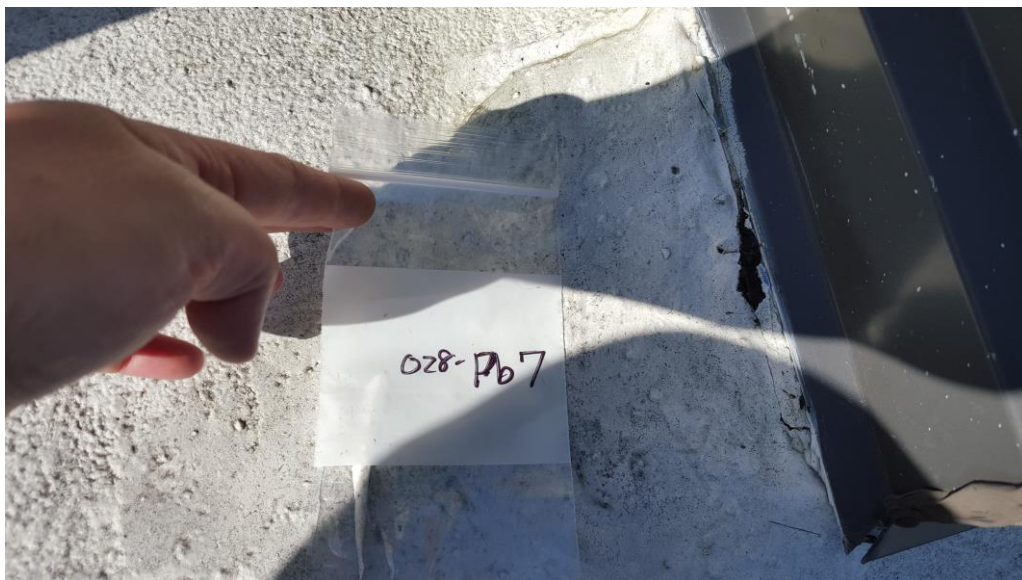
028-Pb7
White paint on rooftop tar
[Building 64 Penthouse B Rooftop]

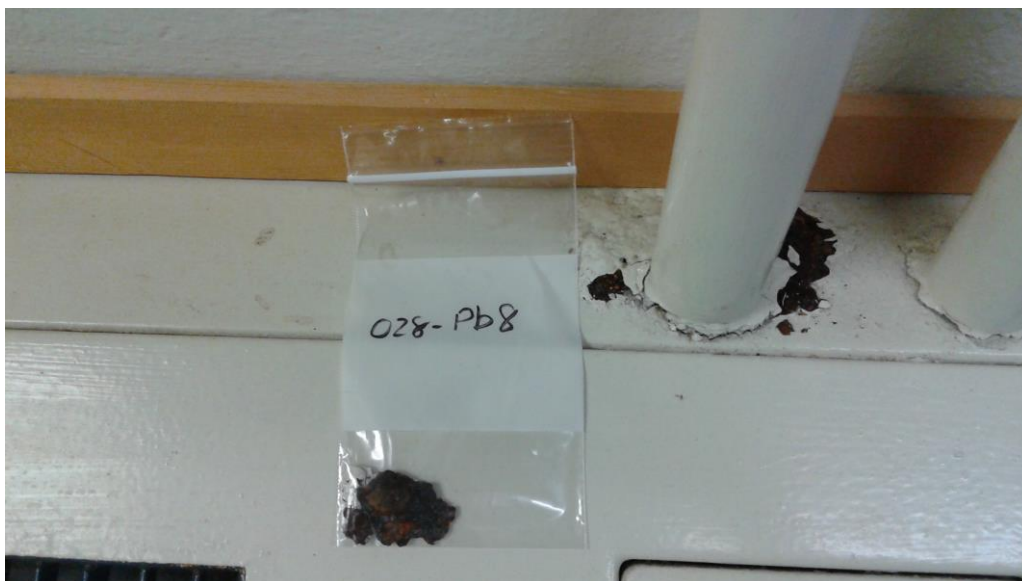
028-Pb8
Beige paint on individual AHU
[Building 19 Room B11]

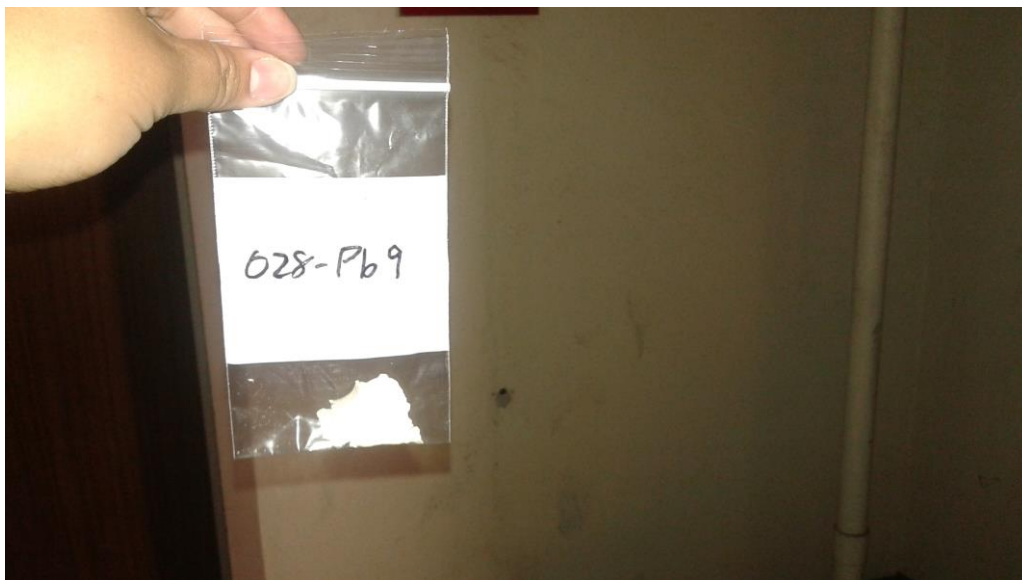
028-Pb9

Beige paint on concrete wall (LCP)
[Building 38 Elevator Machinery Room]
